Detecting problems in buildings using infrared cameras

Application Note

Testing Functions Case Study

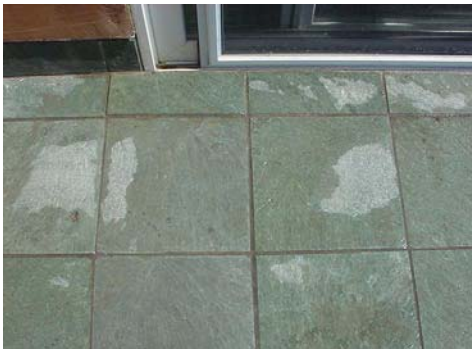
Water running underneath the tile deck into the unit below.
